# Manhole Inspection Summary

Manhole # S23K\_\_052MH

Insp Date: **6/11/08 11:40 AM**

**Location** Address: **310 S Caulhoun St (behind in alley)** Cross Street: **S Norris St**

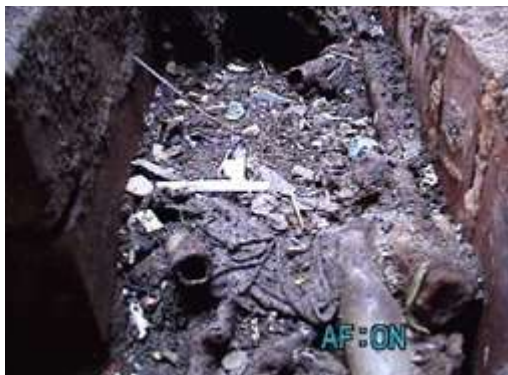
Defect 3

Condition: ☐ Sound ☐ Cracked ☐ Root Intrusion ☐ Deteriorated ☐ Leaks ☒ **Debris**

Debris in channel

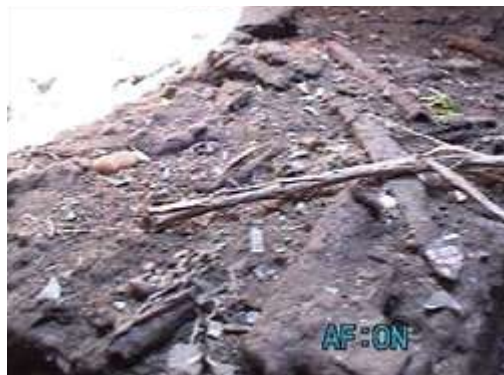
Defect 2

Condition: ☐ Sound ☐ Cracked ☐ Root Intrusion ☐ Deteriorated ☐ Leaks ☒ **Debris**

debris on bench

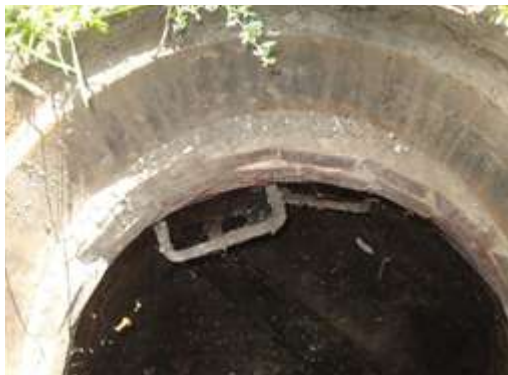
Defect 1

**Frame** Offset: **2** (in.) Condition: ☐ Sound ☐ Cracked ☒ **Leaks**

frame-lid infiltration

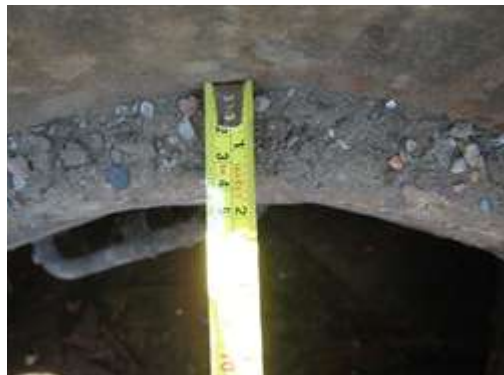
Defect 4

2" offset

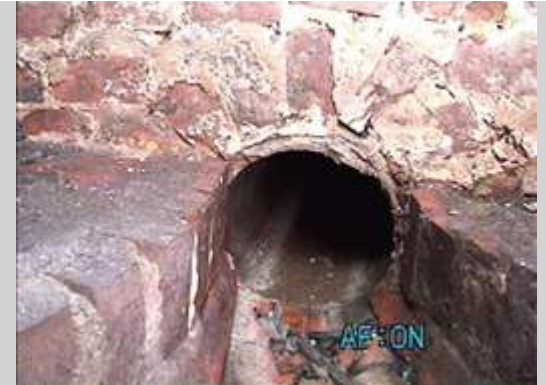
12 O'Clock Outflow

Pipe Height: **8.4** (in.) Rod and Bar (Angled)  
Pipe Material: **Clay** ☐ Pipe Lined  
Invert Depth: **5.27** (ft.) Flow Characteristics: **None**  
Deposits: ☒ None ☐ Mud ☐ Sludge ☐ Debris ☐ Grease  
Silt Depth: **0** (in.) Deposits Extent:  
Infiltration: **None** Pipe Seal Cond: **Sound**

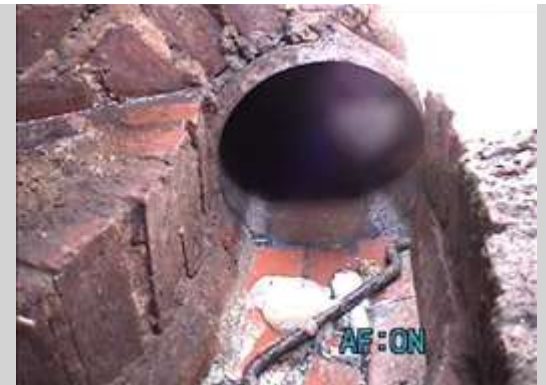
4 O'Clock Inflow

Pipe Height: **8.4** (in.) Rod and Bar (Angled)  
Pipe Material: **Clay** ☐ Pipe Lined  
Invert Depth: **5.08** (ft.) Flow Characteristics: **Slow**  
Deposits: ☒ None ☐ Mud ☐ Sludge ☐ Debris ☐ Grease  
Silt Depth: **0** (in.) Deposits Extent:  
Infiltration: **None** Pipe Seal Cond: **Sound**

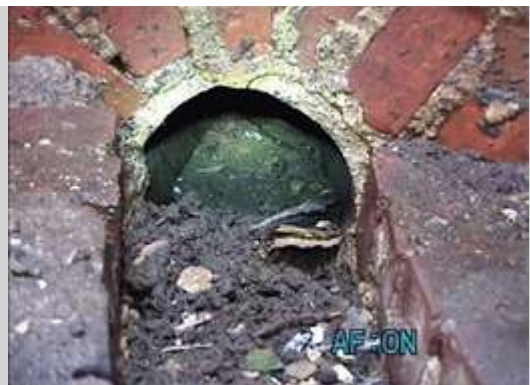
8 O'Clock Inflow

Pipe Height: **4.8** (in.) Rod and Bar (Angled)

Invert Depth: **4.75** (ft.) Flow Characteristics: **None**

Pipe Seal Cond: **Sound**
